This report shows all the responses to the Fire Risk Assessment survey, including raised tasks.

Asset ID: 33210 **19-21 Alder Close Block 19-21, Leyland**

Date of Fire Risk Assessment	02 Jun 2023
Date of Next Fire Risk Assessment	02 Jun 2026
FRA Frequency (Months)	36
Purpose of Fire Risk Assessment	3 year Re-Assessment
Type of Fire Risk Assessment	Type 1 (Common Parts Only - Non Destructive)
Fire & Safety Assessor	Ian Potter

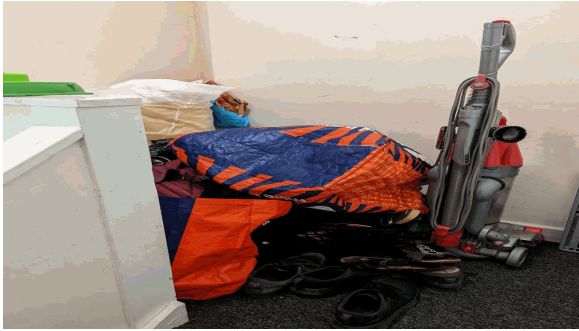
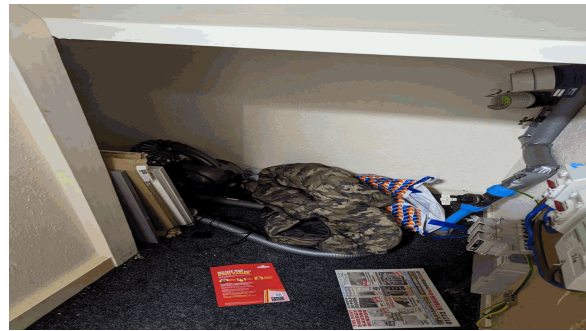
Are all electrical/intake/service cupboards secure and free from general waste, contractors waste and residents personal items? No

Comment Personal items in electrical cupboard of 21

Are unnecessary accumulations of combustible materials or waste avoided? No

Comment Personal items stored in Communal areas outside 19B and 20B

Observation	Priority	Referred To	Required By:	Task ID
Personal items stored in communal areas outside 19B and 20B and in electrical cupboard of 21. Customers to be informed to remove these items.	Internal - Low	Housing Partner	31/08/2023	1680733
